**A STUDY OF SEVERAL OXIDATION-RESISTANT
COATINGS ON Cb-10Ti-5Zr ALLOY SHEET**

**AT 2000° F, 2400° F, AND 2700° F
(1365° K, 1590° K, AND 1755° K)**

by W. Barry Lisagor and Bland A. Stein

Langley Research Center

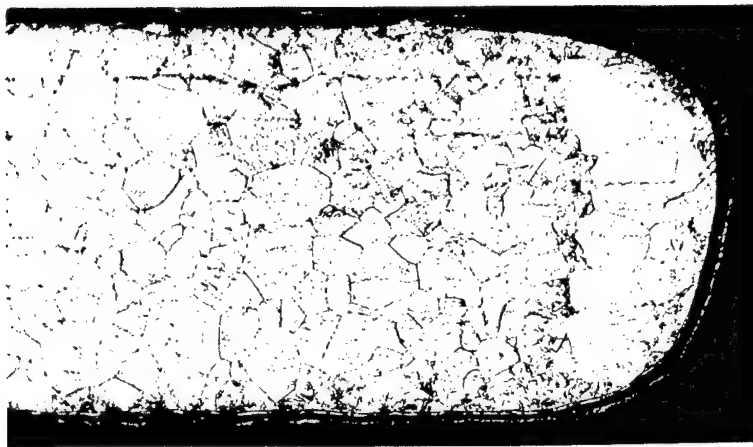
(a) As-coated appearance, X 2.

(b) Cross section, X 100.

(c) Cross section, X 500.

Figure 2.- Appearance of coating 1 on Cb-10Ti-5Zr alloy sheet in the as-coated condition.

Coating 1.- A relatively high columbium intensity was noted in the X-ray emission examination of the surface of coating 1. Also identified were Ti, Cr, Zr, Fe, and Si. The Fe intensity was high whereas the Si intensity was low. X-ray diffraction analysis indicated the primary compound to be CbB_2 . It should be noted here that boron is presently unidentifiable by X-ray emission techniques because the low-energy characteristic X-rays of boron cannot be detected. The as-received appearance of specimens of coating 1 is shown in figure 2. Substrate appearance may be compared with cross sections of the uncoated columbium alloy sheet in figure 3. The coated surface was dull black in color and relatively smooth in texture, some signs of nonuniformity being indicated by areas of different texture. Comparison of the uncoated grain size (fig. 3) and the substrate grain size in the coated specimen (fig. 2) indicates that some substrate grain growth resulted from the coating procedure. The metallographic studies showed some indications of substrate contamination due to the coating operation as evidenced by the appearance of precipitate particles. However, no indication of a continuous network of contaminants was observed in the substrate.

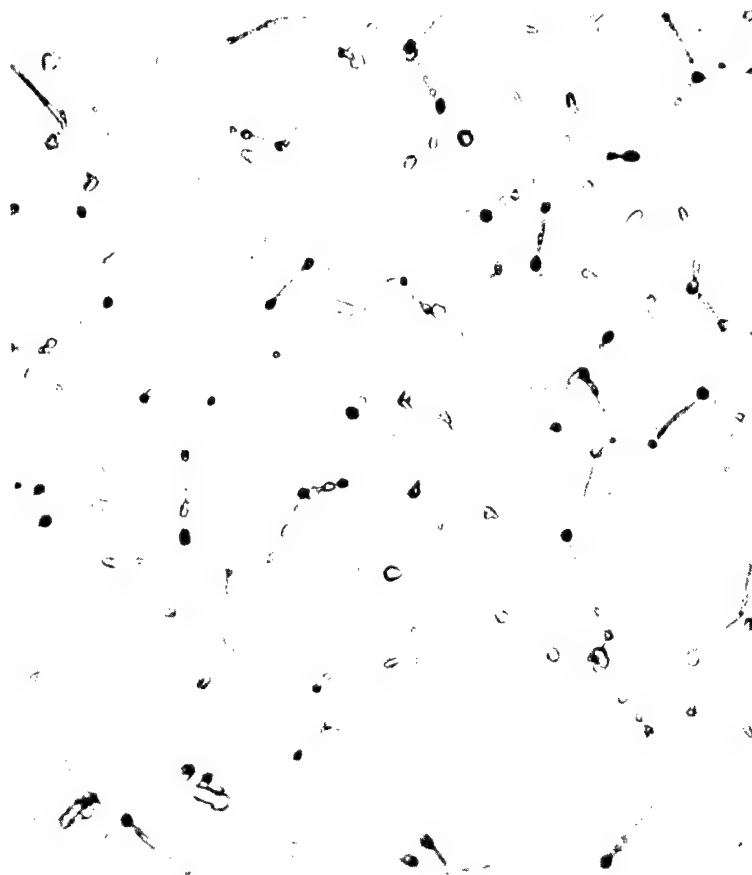
Figure 3.- Photomicrographs of Cb-10Ti-5Zr alloy sheet in the annealed condition.

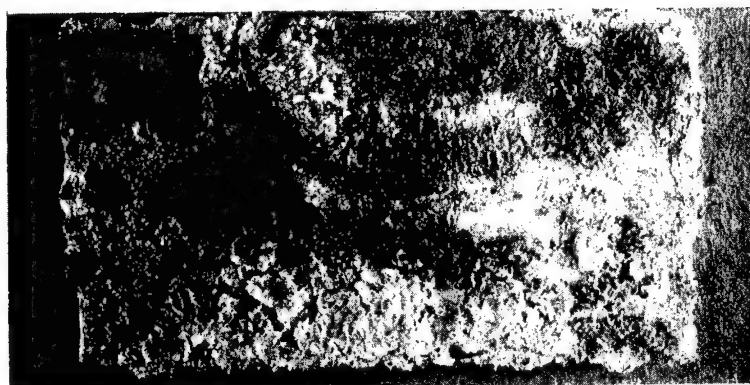
(b) 2-hour exposure at 2400° F (1590° K).

which these rate changes occur was taken as the time of coating failure. For coatings which provide good oxidation protection for the substrate, these points are easily noted as will be seen in subsequent figures. For coating 1, general specimen appearance after exposure was different in color and texture for each of the temperatures investigated as can be seen in figure 5. This behavior indicates that the reaction products may differ in composition for each temperature investigated. The failure at 2000° F (1365° K) appeared to be due to coating failure and oxidation of the substrate whereas failure at 2700° F (1755° K) actually appears to be caused by melting of the reaction products after formation of low melting compositions by solid-state diffusion. All specimens failed very rapidly at 2700° F (1755° K).

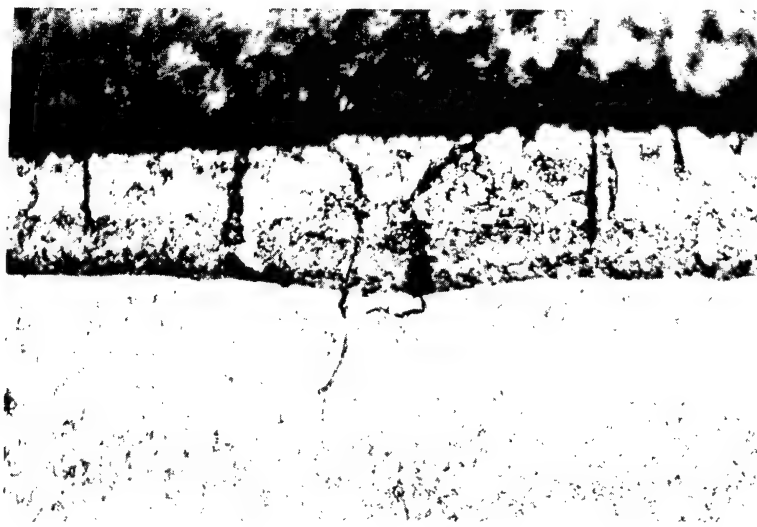
(b) Cross section, X 100.

(c) Cross section, X 500.

Figure 6.- Appearance of coating 2 on Cb-10Ti-5Zr alloy sheet in the as-coated condition.

Coating 2.- Results of the X-ray analysis (table II) showed the same elements present as for coating 1 and again the primary phase identification by X-ray diffraction was CbB₂. Coating appearance in the as-received condition is shown in figure 6. The surface appearance of the coating was similar to that of coating 1, but the coating thickness was approximately twice that of coating 1 (table I). Metallographic examination of coating 2 showed that the substrate itself was more severely affected by contaminants; as a result there was a continuous network of precipitates in the grain boundaries and subsequent severe embrittlement. The room-temperature tensile test results are shown in table III. The marked change in tensile properties indicate severe alteration of the base material by the coating process itself. The process lowered the tensile strength from 76 ksi to 49 ksi (525 to 338 MN/m²) increased the elastic modulus from 15×10^6 to 24×10^6 psi (103 to 166 GN/m²) and completely embrittled the substrate. Results of the elevated-temperature tensile tests (table IV) indicate the resultant specimen is actually stronger at 2400° F than the uncoated material, but tensile elongation was still negligible at 2000° F (1365° K) and only 4 percent at 2400° F (1590° K). Results of the bend tests also indicated complete embrittlement of substrate as found in the tensile tests (table I).

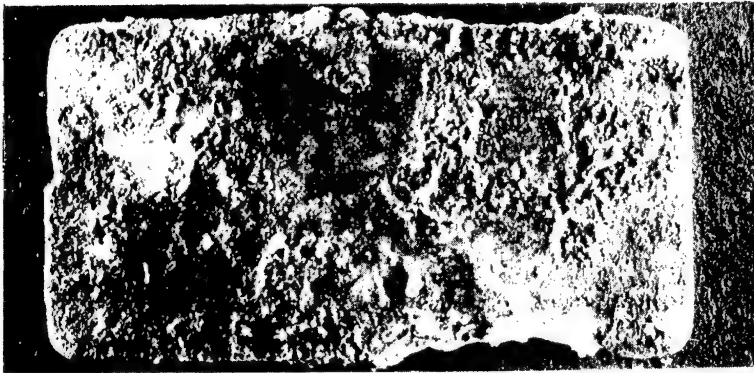
(a) 69-hour exposure at 2000° F (1365° K).

(b) 4-hour exposure at 2400° F (1590° K).

Figure 8.- Photographs of tested specimens of coating 2 on Cb-10Ti-5Zr alloy sheet exposed in air at atmospheric pressure, X 2.

Results of the cyclic and continuous oxidation tests are shown in figure 7, and the appearances of exposed specimens are shown in figure 8. Again, as was noted in coating 1, specimen appearance after exposure suggested different reaction products at all three test temperatures. Failure at 2700° F (1755° K) occurred immediately on insertion into the furnace and appeared to be caused by melting of the specimen rather than by oxidation of the substrate.

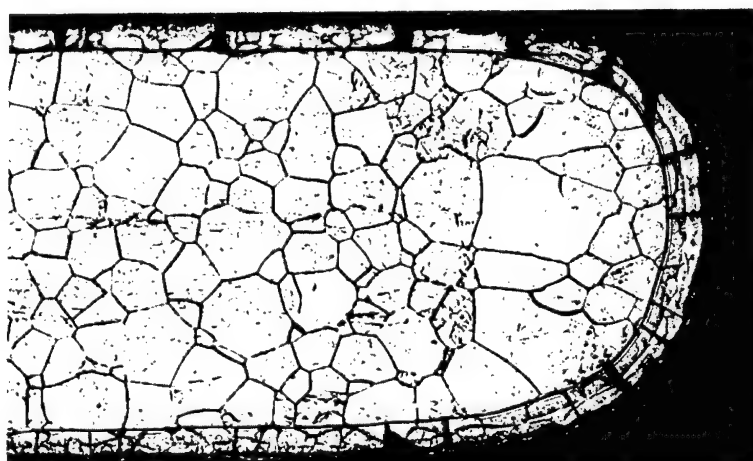
Figure 9.- Appearance of coating 3 on Cb-10Ti-5Zr alloy sheet in the as-coated condition.

Coating 3.- Although the coating procedure consisted of a first cycle of silicon and a second cycle of chromium and boron, the primary outer structure was found to be CbSi₂ and Cb₅Si₃ (table II). The appearance of this coating in the as-received condition is shown in figure 9. The coating appearance was dull gray, relatively smooth in texture, but had some darker spots dispersed over the entire coating. Once again, grain growth

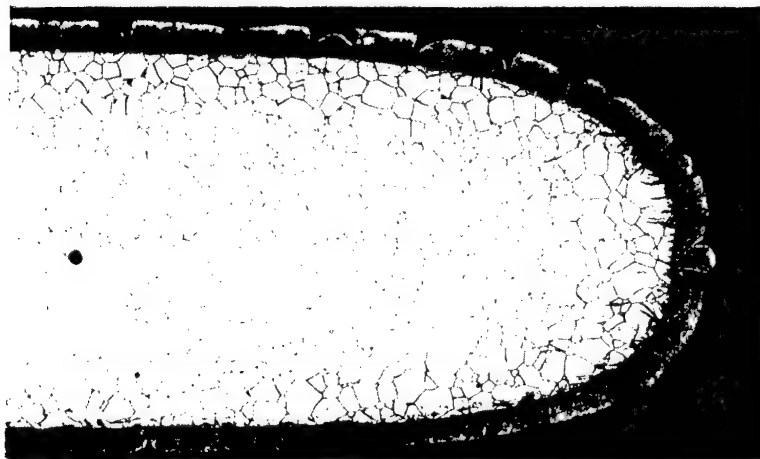
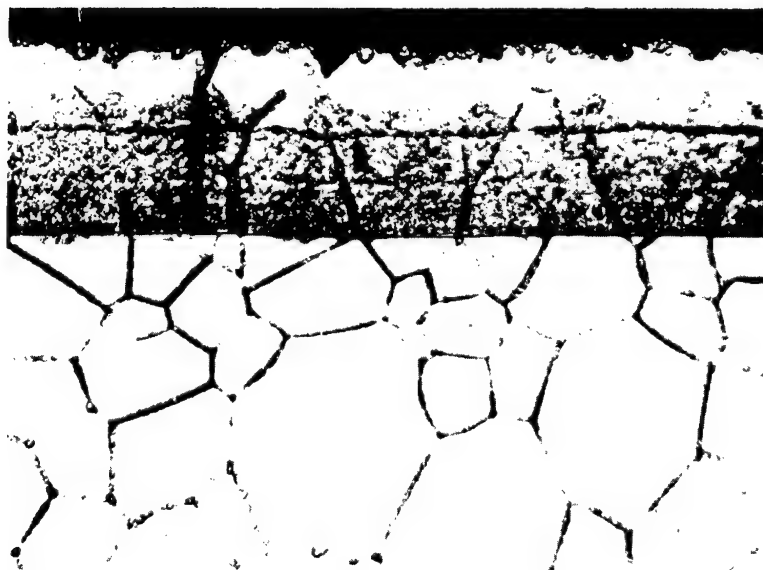
—SiC overcoat

Figure 16.- Appearance of coating 5 on Cb-10Ti-5Zr alloy sheet in the as-coated condition, showing SiC overcoat layer.

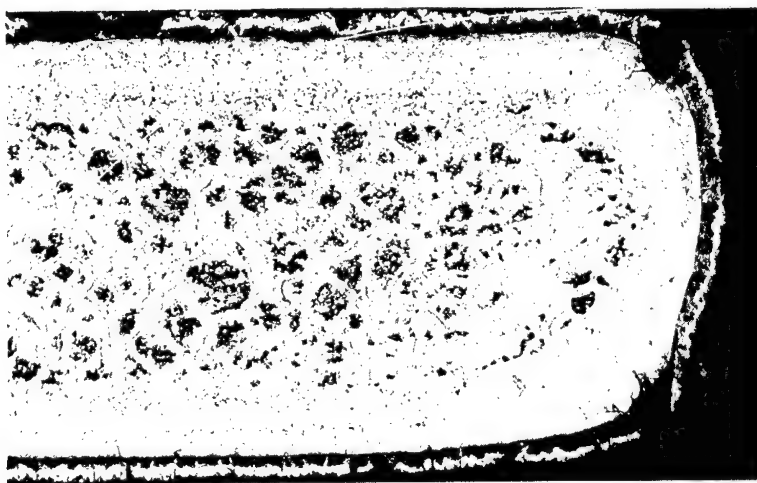
Figure 19.- Appearance of coating 6 on Cb-10Ti-5Zr alloy sheet in the as-coated condition.

Coating 6. - Results of the X-ray study on coating 6 (table II) indicate a relatively low silicon and columbium intensity, high chromium intensity, and appreciable intensity of titanium and chromium. X-ray diffraction and emission comparisons indicate the primary compound to be a solid solution of CbSi₂ and CrSi₂. The appearance of this coating in the as-received condition is shown in figure 19. The surface appearance was very uniform, light gray in color, and smooth in texture, but metallographic examination

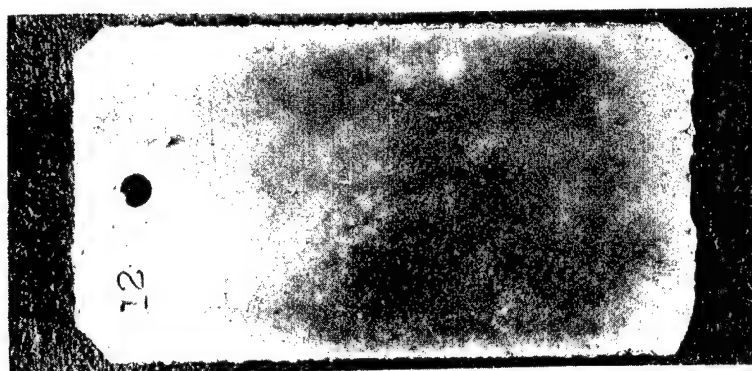
(a) 144-hour exposure at 2000° F (1365° K).

(b) 75-hour exposure at 2400° F (1590° K).

Figure 21.- Photographs of tested specimens of coating 6 on Cb-10Ti-5Zr alloy sheet exposed in dry air at atmospheric pressure under the conditions noted, X 2.

Results of the oxidation tests at atmospheric pressure (101 kN/m^2) are shown in figure 20 and the appearances of the exposed specimens are shown in figure 21. There was little damage at 2000° F (1365° K) before 140-hours exposure. At 2400° F (1590° K) severe damage began after approximately 30-hours exposure. At 2700° F (1755° K) tests were terminated from 1 to 24 hours.

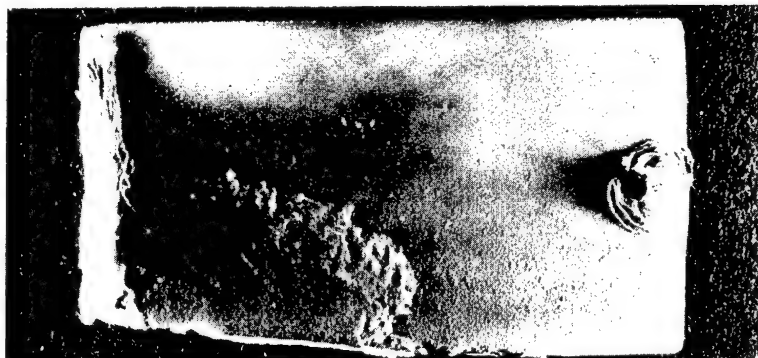
(a) 113-hour exposure at 2000° F (1365° K).

(b) 5-hour exposure at 2400° F (1590° K).

(c) 0.5-hour exposure at 2700° F (1755° K).

Results of the oxidation tests are shown in figure 23 and macro-photographs of exposed specimens are shown in figure 24. Oxidation protection afforded by this coating was poor, probably because the coating was relatively thin.

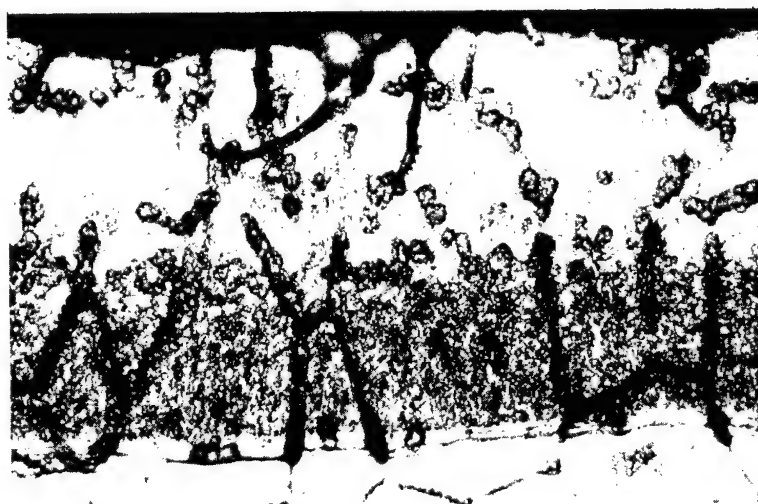
Figure 29.- Appearance of coating 9 on Cb-10Ti-5Zr alloy sheet in the as-coated condition.

Coating 9. - The X-ray study on coating 9 resulted in identification of chromium, titanium, and silicon from the coating process with intensities as reported in table II; columbium and zirconium from the substrate were also identified. The primary compound was identified as a solid solution of CrSi_2 and CbSi_2 . The appearance of coating 9 is shown in figure 29 in the as-received condition. The metallographic examinations revealed severe alteration of the base material by the coating process, with general precipitation of particles. The coating process did not cause appreciable grain growth.

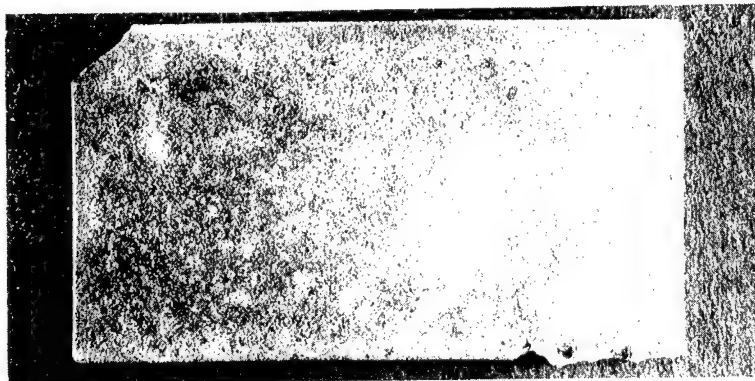
(a) 143-hour exposure at 2000° F (1365° K).

(c) 4-hour exposure at 2700° F (1455° K).

Results of the oxidation study at atmospheric (101 kN/m^2) pressure are presented in figure 30 and photographs of exposed specimens are shown in figure 31. Protection at 2000° F (1365° K) was good for a minimum of 140 hours, but protection at 2400° F (1590° K) was reduced somewhat. At 2700° F (1755° K) failures occurred after 4.3 and 45 hours.

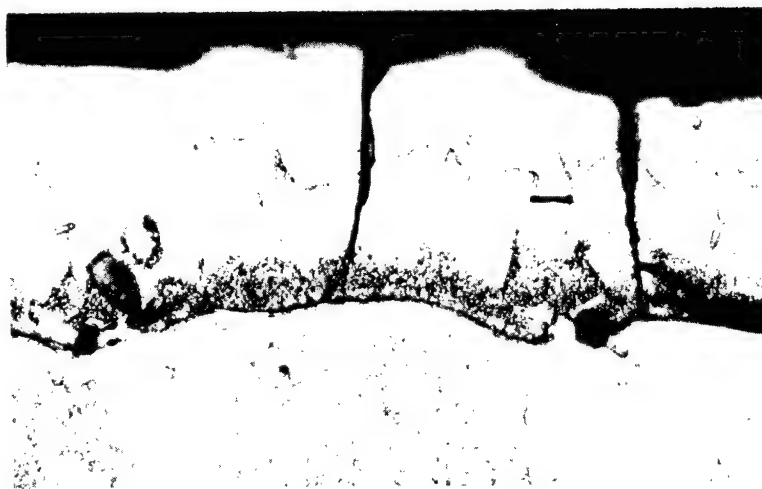
Figure 39.- Appearance of coating 12 on Cb-10Ti-5Zr alloy sheet in the as-coated condition.

Coating 12.- Results of the X-ray study on coating 12 indicate that this coating had the highest intensities of chromium and silicon relative to the other coatings and a high intensity of titanium (table II). Lower intensities of columbium and zirconium were also observed. The primary crystal structure was that of $\text{CrSi}_2\text{-CbSi}_2$ solid solution. Views of this coating in the as-received condition are shown in figure 39. This coating was also speckled gray in appearance and had a medium smooth texture. Metallographic examinations indicate no precipitates in the substrate. A well-defined diffused layer and considerable grain growth were evident after the coating process. Room-temperature tensile data indicate no change in tensile strength due to the coating application, but a decrease in elongation from 30 to 14 percent was observed (table III). Specimens exposed at 2400° F for 8 hours exhibited a further reduction in elongation to 4 percent. Elevated-temperature tensile tests (table IV) indicated that the ultimate strength was similar to that of the uncoated material and specimens of other coatings.

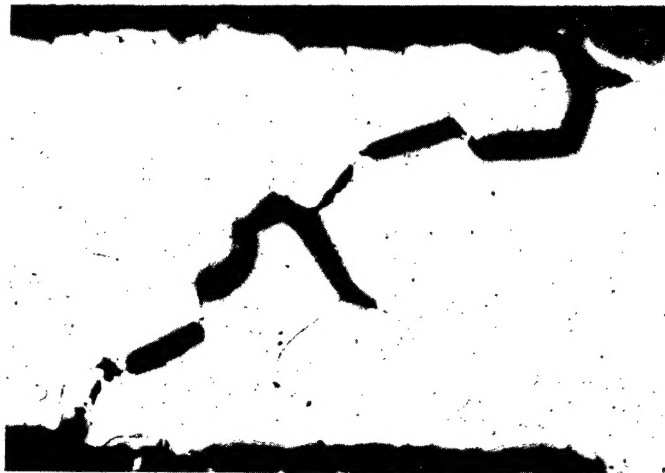
(a) Bright-field illumination, metallograph, X 100.

Figure 46.- Cross sections of a specimen of coating 12, after 240 one-hour cycles at 2000° F (1365° K) in air at 760 mm Hg (101 kN/m²) and a room-temperature bend test.

The oxidation and bend-test results indicate that specimens of this coating exhibited embrittlement of the substrate when cyclically exposed, and showed no evidence of oxidation damage. After 240 one-hour cycles at 2000° F there was no visual evidence of failure and no mass changes of large magnitude; however, bend tests resulted in brittle fracture (table V). The specimen tested continuously for 240 hours at 2000° F was not embrittled. Reduced pressure tests at 0.05 torr resulted in severe embrittlement after 20 one-hour cycles at 2400° F with no obvious oxidation damage.
